Confidential Inspection Report

Wednesday, March 14, 2018
Linda Flinkman
1820 Garland Ln
Boulder, CO 80304

We have enclosed the report for the Mold inspection we conducted for you on Wednesday, March 14, 2018 at:

1234 Boulder, CO
80301

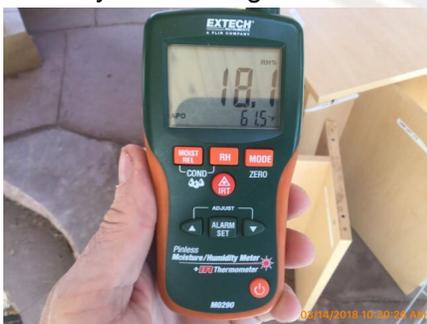
Exterior ambient

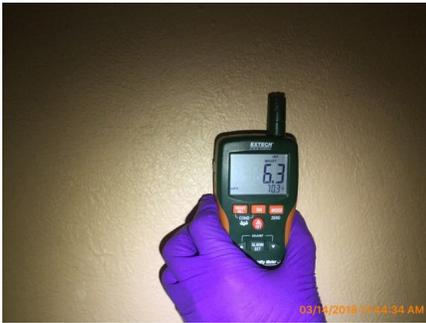
AMBIENT READINGS: Moisture surface reference taken on interior wall drywall at stairs approximately 20' from office.

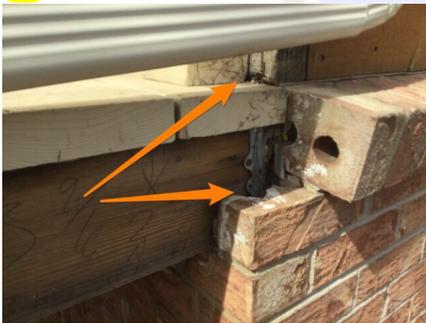
CAUT The deck was in bad condition. We recommend repair or replacement.

These areas should be caulked and flashed to prevent water intrusion

- ^a the areas of the deck with inadequate or missing flashing should be repaired by a qualified professional

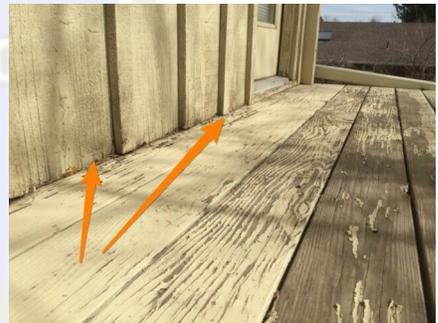
Modern building practices require flashing and the separation between the deck and the siding

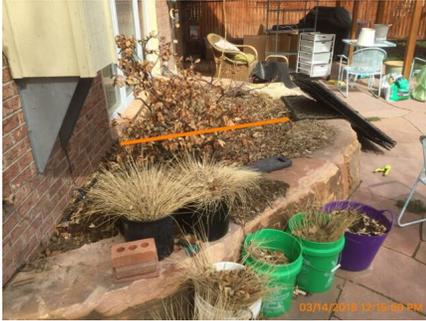
WARN There was negative grading on the east side of the home. The area between the flagstone walkway and the house does not have sufficient slope to move water away from the foundation. This is likely contributing to the moisture intrusion in the office

Planter drains toward house

- ^a sprinklers should have heads installed that direct water away from the walls and foundation.
- ^a if negative grading cannot be corrected (I.e. areas next to walkways) we recommended the installation of a French drain along the surface perimeter of the foundation to assist with removing groundwater.

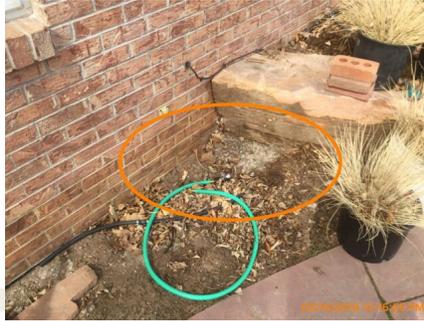
This area has no way to move excessive moisture away from the foundation

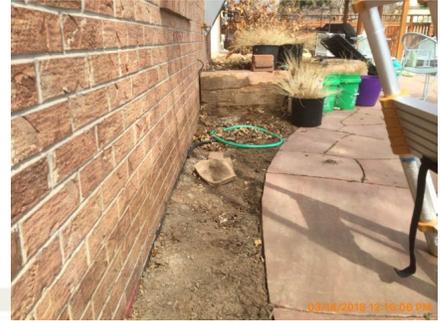
Inadequate drainage

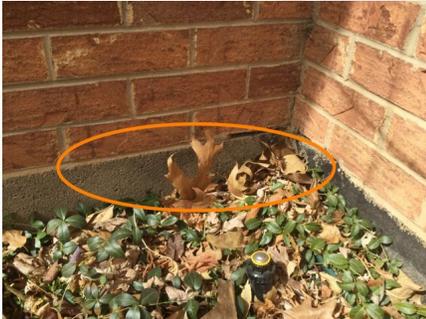
WARN The exterior SW corner of the office showed evidence of moisture movement next to the foundation. This is directly adjacent to suspected biological growth in the office, and where evidence of moisture on the carpet and rusting from the file cabinet was noticed. It appears that the waterproofing on the foundation stopped before this area. It is highly probable that the sprinkler was flooding this area and allowing moisture to penetrate through the foundation at the footing.

No waterproofing on west wall

- ^a A foundation waterproofing system should be sprayed or painted on any foundation area that is below grade.
- ^a a landscape barrier fabric should be installed along the foundation and slope away from the foundation to assist in directing groundwater away from the foundation.

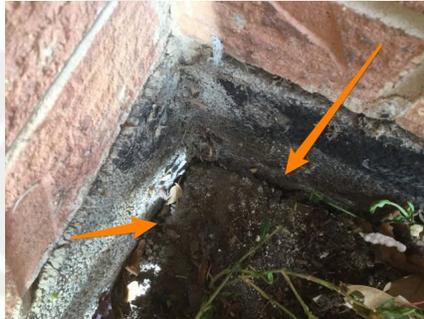
Areas where soil has pulled away from foundation creating pathway for moisture

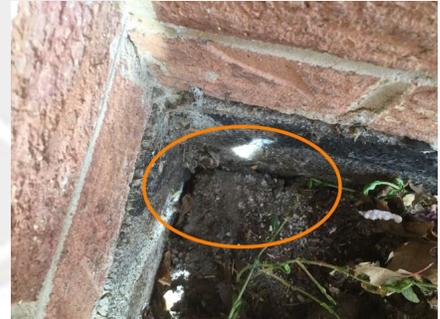
Areas where soil has pulled away from foundation creating pathway for moisture

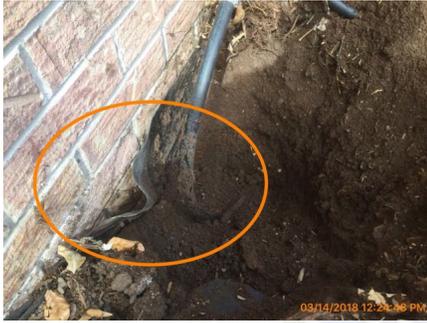
WARN The raise planter on the east side of the building had insufficient drainage. Additionally the liner was installed incorrectly. The liner was not sealed to the foundation wall and was below the soil grade. This could potentially allow water to saturate the soil build up, and over top the liner, resulting in water being trapped between the liner and the foundation. Additionally, there were no weep holes or other drainage options observed that would allow water from the planter to drain away from the foundation. Modern building practices require adequate waterproofing and drainage of planters to prevent moisture from building up.

Liner can allow water intrusion

- ^a the raised planter on the E of the building should have weep holes on the exterior to allow excess water to drain away from the building. Additionally the liner that is currently installed should be removed and foundation waterproofing should be sprayed in that area. The installation of foundation waterproofing, a perimeter drain, and weep-holes/adequate drainage of the planter should negate the need for a liner.

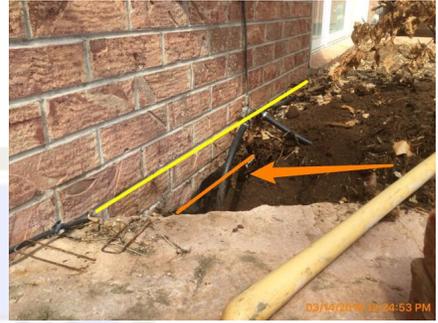
Top of liner located below soil surface

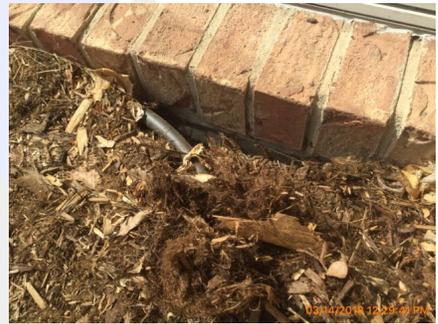
Mulch/soil level at window for reference

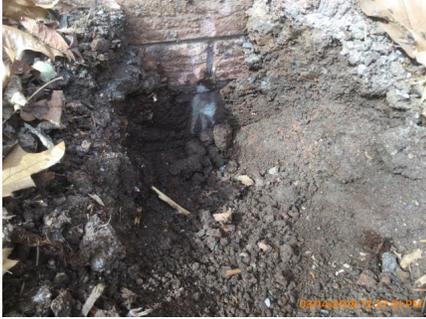
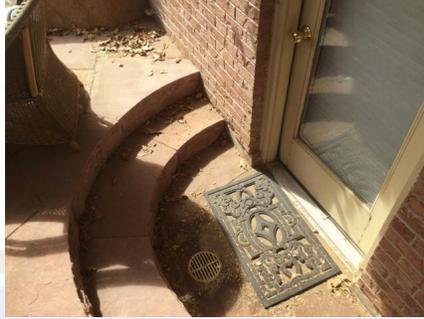
CAUT Two areas were excavated to a depth of approximately 12 to 18 inches. No evidence of perimeter drains was located. Homeowner was not aware of any perimeter drains based on excavation to footing where waterproofing was applied on SE corner of office. Perimeter drains and French drains are an important component in building design to prevent moisture intrusion.

Drain located at steps, appeared to be functional

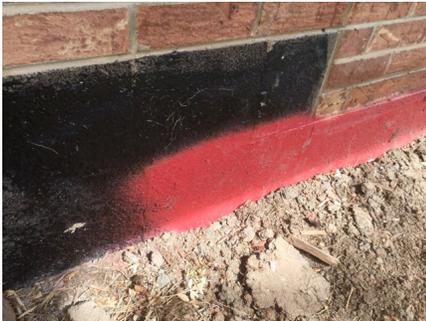
CAUT The foundation waterproofing appeared to be in marginal condition. There were areas of the foundation missing waterproofing. Paint-on or spray-on foundation waterproofing is used in addition to perimeter drainage to help prevent hydrostatic moisture pressure from penetrating below-grade walls.

Homeowner applied waterproofing

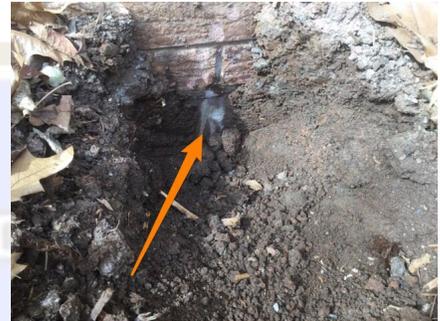
Area next to raised planter with no waterproofing

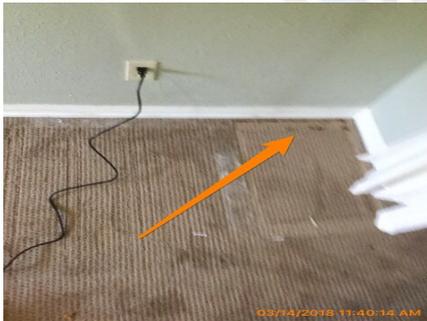
Rust on carpet where a file cabinet was located

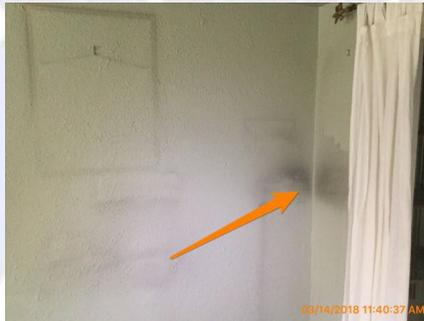
Swab iws1

SAMP Sample # iws1 (swab) and iws2 (interior wall), approved samples collected. Items with this rating have had samples taken that have been authorized by the owner or the inspector for laboratory submission. There was visible evidence of an apparent biological contamination in the SE corner of the office. No other visible signs of moisture or mold damage were observed.

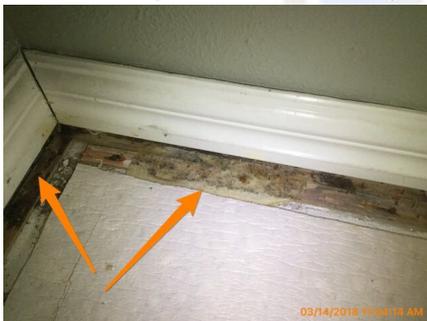
WARN There is visible evidence of a mold condition or a condition conducive to mold growth (Visible moisture, high moisture readings, leaking pipes, etc.).

NE corner of office Evidence of mold

There is sufficient evidence to indicate more than 10 ft.² of possible mold contamination in the wall cavities and under the flooring. We recommend hiring a certified mold remediation company to remove contaminated material. We recommend using the EPA's 'Mold Remediation in Schools and Commercial Buildings Guide' as a baseline.

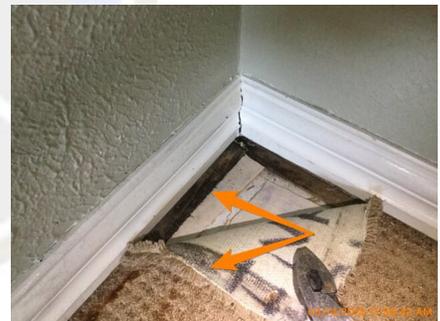
SW corner of office evidence of mold

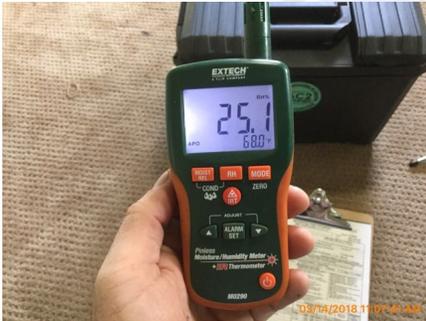
Normal readings as compared to ambient exterior conditions

SE Office ambient

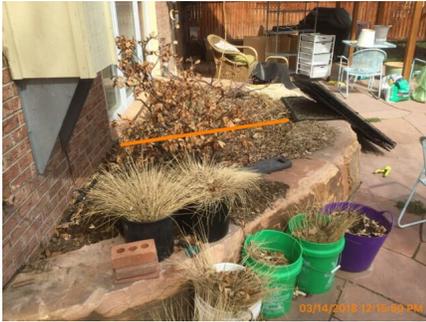
WARN 1: - There was negative grading on the east side of the home. The area between the flagstone walkway and the house does not have sufficient slope to move water away from the foundation. This is likely contributing to the moisture intrusion in the office

Planter drains toward house

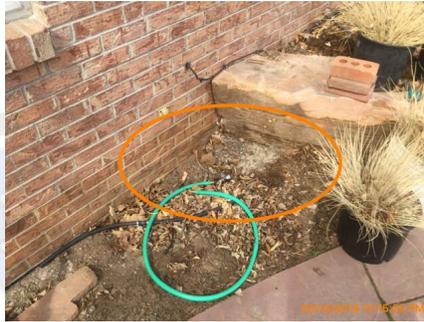
This area has no way to move excessive moisture away from the foundation

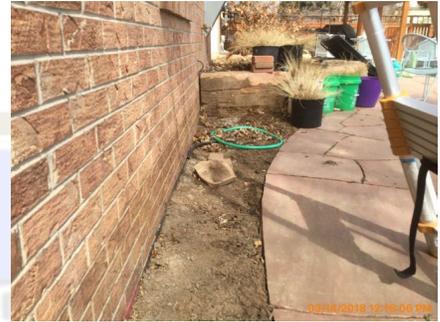
Inadequate drainage

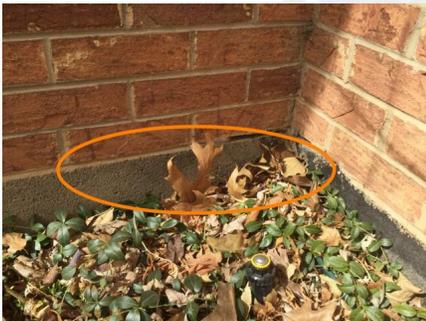
WARN 2: - The exterior SW corner of the office showed evidence of moisture movement next to the foundation. This is directly adjacent to suspected biological growth in the office, and where evidence of moisture on the carpet and rusting from the file cabinet was noticed. It appears that the waterproofing on the foundation stopped before this area. It is highly probable that the sprinkler was flooding this area and allowing moisture to penetrate through the foundation at the footing.

No waterproofing on west wall

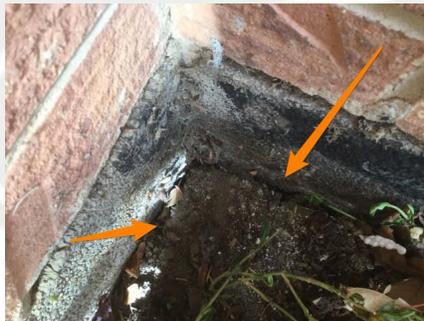
Areas where soil has pulled away from foundation creating pathway for moisture

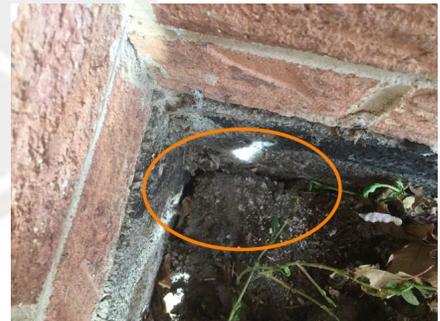
Areas where soil has pulled away from foundation creating pathway for moisture

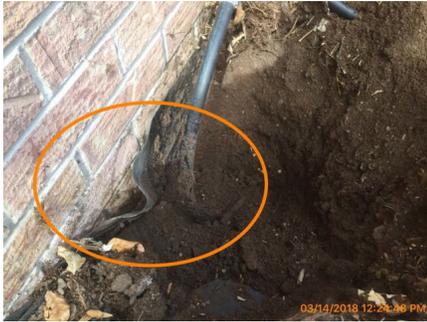
WARN 3: - The raise planter on the east side of the building had insufficient drainage. Additionally the liner was installed incorrectly. The liner was not sealed to the foundation wall and was below the soil grade. This could potentially allow water to saturate the soil build up, and over top the liner, resulting in water being trapped between the liner and the foundation. Additionally, there were no weep holes or other drainage options observed that would allow water from the planter to drain away from the foundation. Modern building practices require adequate waterproofing and drainage of planters to prevent moisture from building up.

Liner can allow water intrusion

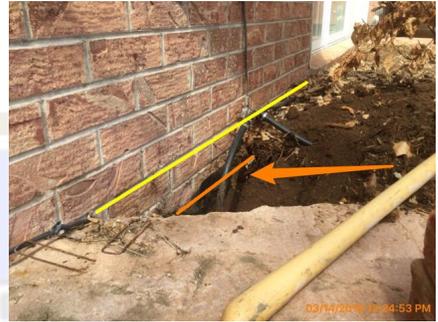
Top of liner located below soil surface

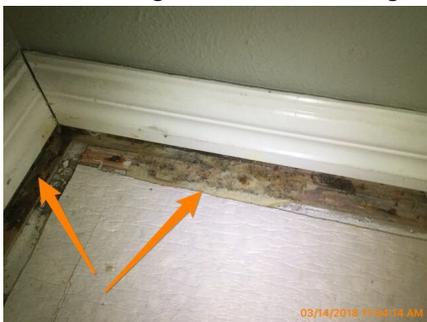
WARN 4: - There is visible evidence of a mold condition or a condition conducive to mold growth (Visible moisture, high moisture readings, leaking pipes, etc.).

NE corner of office Evidence of mold

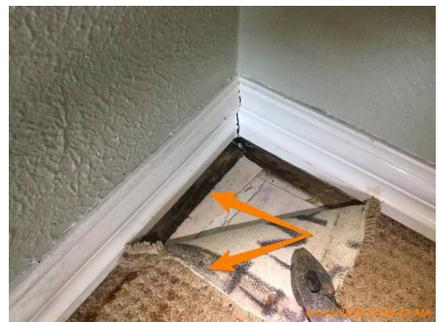
SW corner of office evidence of mold

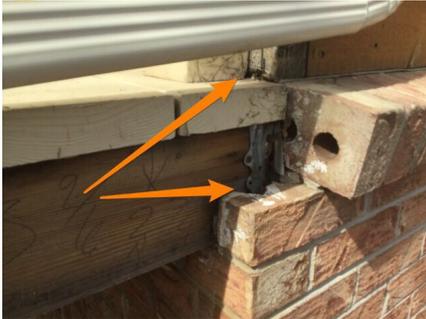
CAUT 5: - The deck was in bad condition. We recommend repair or replacement.

These areas should be caulked and flashed to prevent water intrusion

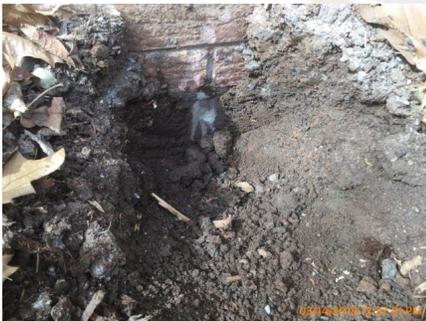
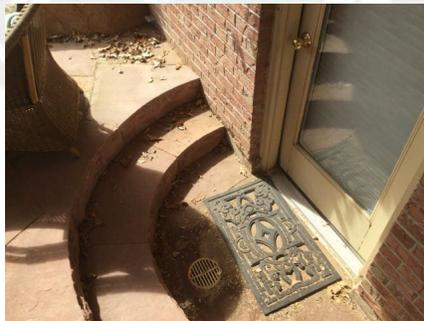
CAUT 6: - Two areas were excavated to a depth of approximately 12 to 18 inches. No evidence of perimeter drains was located. Homeowner was not aware of any perimeter drains based on excavation to footing where waterproofing was applied on SE corner of office. Perimeter drains and French drains are an important component in building design to prevent moisture intrusion.

Drain located at steps, appeared to be functional

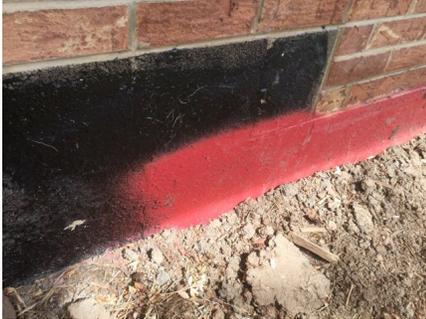
CAUT 7: - The foundation waterproofing appeared to be in marginal condition. There were areas of the foundation missing waterproofing. Paint-on or spray-on foundation waterproofing is used in addition to perimeter drainage to help prevent hydrostatic moisture pressure from penetrating below-grade walls.

Homeowner applied waterproofing

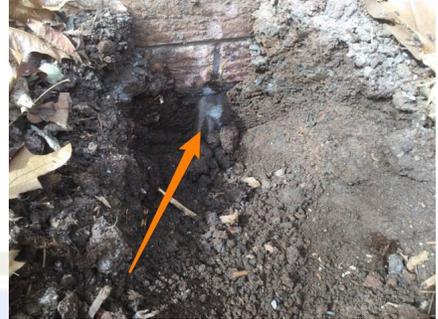
Area next to raised planter with no waterproofing
