Confidential Inspection Report

Wednesday, March 14, 2018
Linda Flinkman
1820 Garland Ln
Boulder, CO 80304

We have enclosed the report for the Mold inspection we conducted for you on Wednesday, March 14, 2018 at:

1234 Boulder, CO
80301

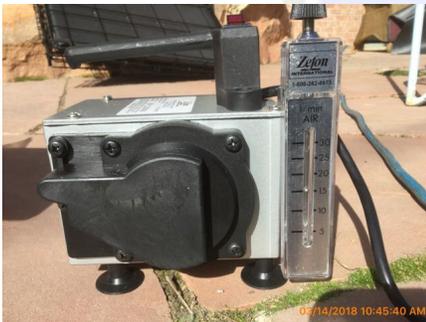
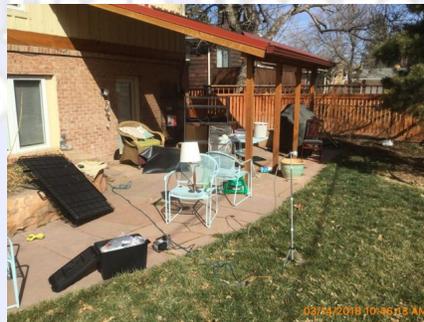
SAMP Sample # A10 An approved sample collected. Items with this rating have had samples taken that have been authorized by the owner or the inspector for laboratory submission. This was an outdoor control sample.

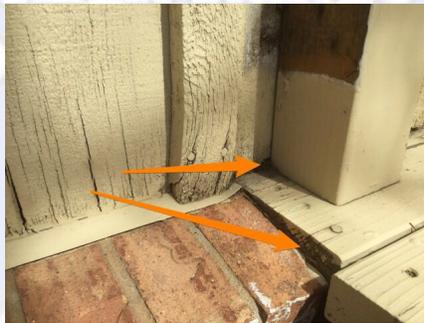
These areas should be caulked and flashed to prevent water intrusion

- ^a the areas of the deck with inadequate or missing flashing should be repaired by a qualified professional

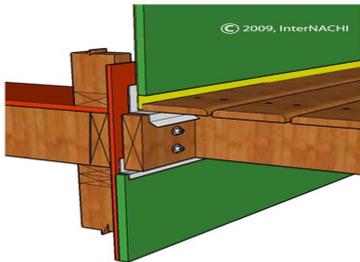
Ledger Flashing

Modern building practices require flashing and the separation between the deck and the siding

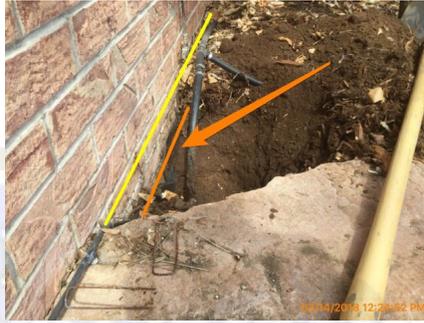
WARN The raise planter on the east side of the building had insufficient drainage. Additionally the liner was installed incorrectly. The liner was not sealed to the foundation wall and was below the soil grade. This could potentially allow water to saturate the soil build up, and over top the liner, resulting in water being trapped between the liner and the foundation. Additionally, there were no weep holes or other drainage options observed that would allow water from the planter to drain away from the foundation. Modern building practices require adequate waterproofing and drainage of planters to prevent moisture from building up.

Top of liner located below soil surface

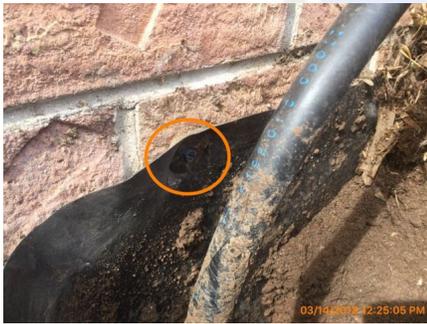
Liner attached to house with screws, no sealing

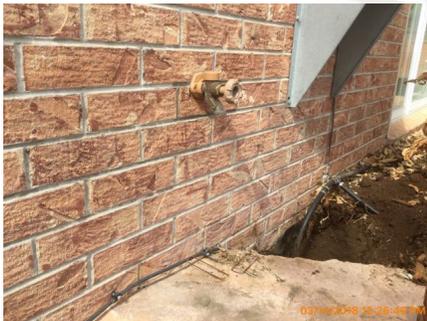
Faucet at planter

The faucet is functional And was not leaking at time of inspection.

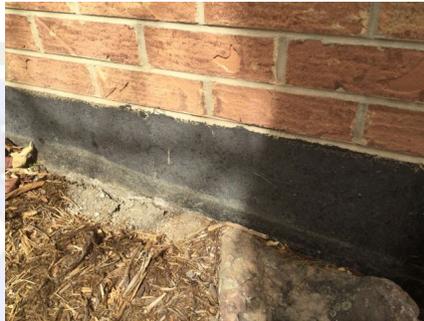
Homeowner applied waterproofing

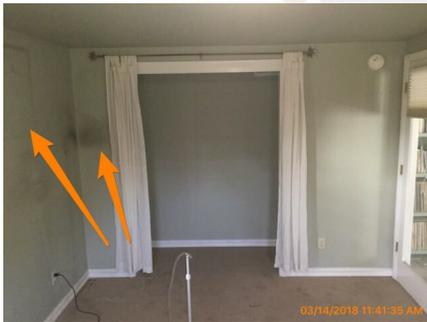
Suspected biological substance

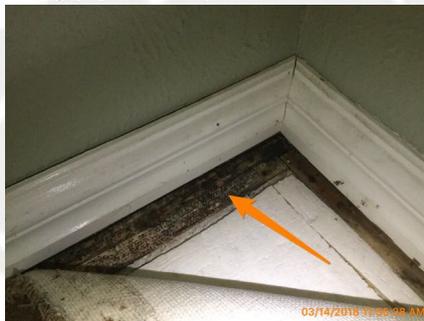
Additionally carpet in each corner of the office was pulled up after air sampling to look for visual indications of water damage or mold. Mold was observed on the tack strip for the carpeting in the NE, SE and SW corners of the office. On the exterior of the house the soil in the planter boxes and along the E and S walls were dry on the surface.

SE corner of office Evidence of mold

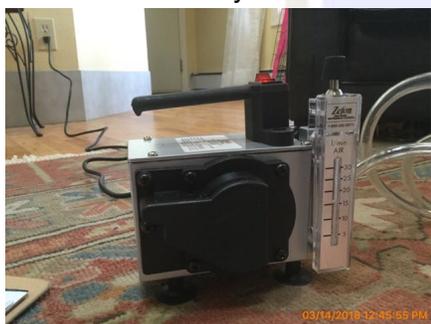
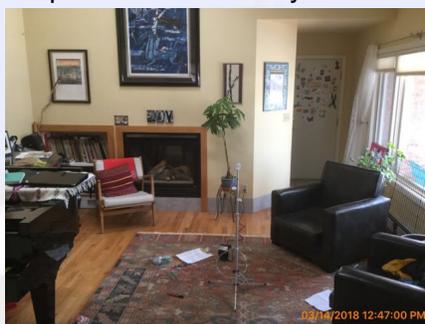
The indoor ambient air sample in the living room (A2i) showed a higher Aspergillus/Penicillium count than the downstairs office. The count in this area may be higher due to several possibilities; there is more air movement in the living room and more disturbance of surfaces such as carpets and couches than in the office area. The office area has had relatively still undisturbed air since being sealed up. The previous moisture problem in the vaulted ceiling may be adding to the sport count in the living room area.

Sample # A2i approved sample collected. Items with this rating have had samples taken that have been authorized by the owner or the inspector for laboratory submission.

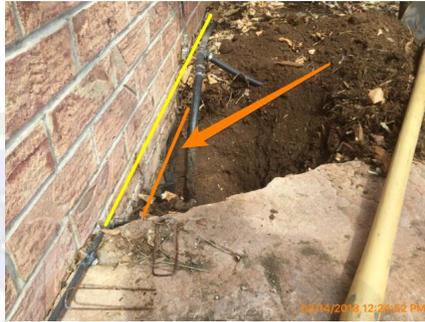
WARN 3: - The raise planter on the east side of the building had insufficient drainage. Additionally the liner was installed incorrectly. The liner was not sealed to the foundation wall and was below the soil grade. This could potentially allow water to saturate the soil build up, and over top the liner, resulting in water being trapped between the liner and the foundation. Additionally, there were no weep holes or other drainage options observed that would allow water from the planter to drain away from the foundation. Modern building practices require adequate waterproofing and drainage of planters to prevent moisture from building up.

Top of liner located below soil surface

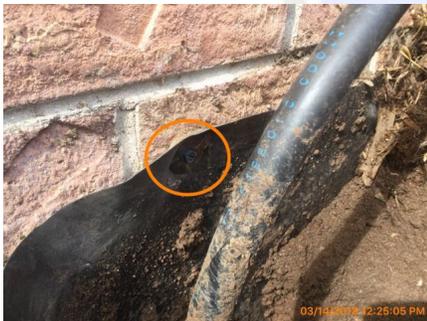
Liner attached to house with screws, no sealing

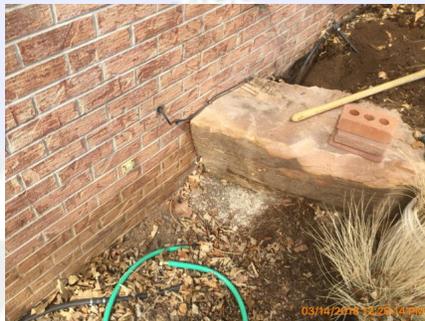
Planter at Wall

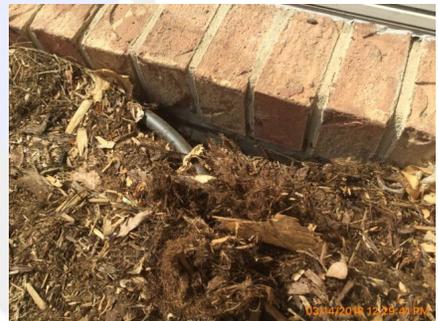
Mulch/soil level at window for reference

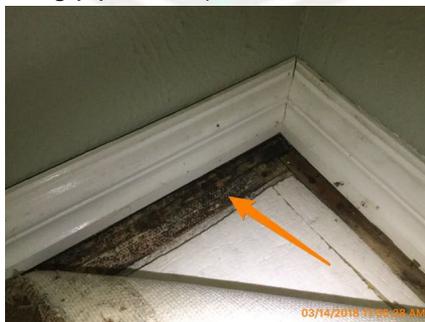
WARN 4: - There is visible evidence of a mold condition or a condition conducive to mold growth (Visible moisture, high moisture readings, leaking pipes, etc.).

SE corner of office Evidence of mold

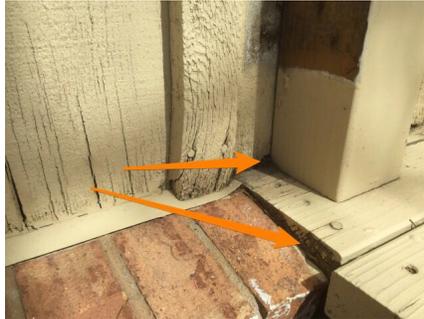
CAUT 5: - The deck was in bad condition. We recommend repair or replacement.

These areas should be caulked and flashed to prevent water intrusion

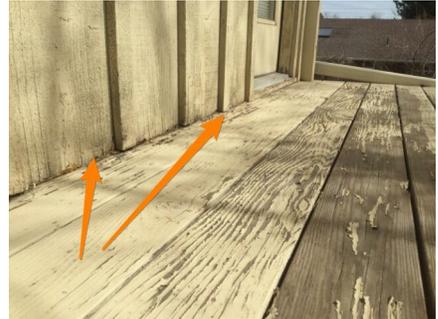
Modern building practices require flashing and the separation between the deck and the siding

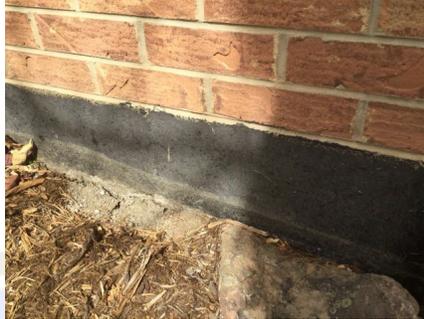
CAUT 7: - The foundation waterproofing appeared to be in marginal condition. There were areas of the foundation missing waterproofing. Paint-on or spray-on foundation waterproofing is used in addition to perimeter drainage to help prevent hydrostatic moisture pressure from penetrating below-grade walls.

Homeowner applied waterproofing
